# Belzona in the Cement Industry

ID: 8545

Application: SHM-Solids Handling Machinery

Ball Mill 4000mm diameter in Germany.

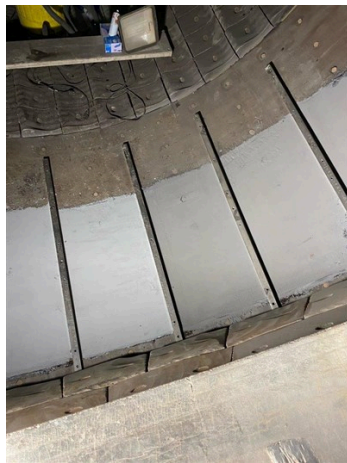
- \* 1: Ball mill in a cement plant (diameter 4000mm) ,
- \* 2: Belzona 4111 and steel base for the right height (for Belzona 4111 and 1812 with two different templates) ,
- \* 3: Every second area complete rebuild with Belzona 1812 (4mm) ,
- \* 4: After removing the steel base 1812 applied in the rest of the area ,
