# BELZONA SUPERWRAP II EXTENDS LIFE OF PIPING BY 10 YEARS

**Industry:** Oil & Gas  
**Application:** VPF-Valves, Pipes and Fittings  
**Substrate:** Carbon Steel  
**Products:** \* Belzona 1983 (SuperWrap II Resin) ,  
\* Belzona 9381 (SuperWrap II Reinforcement Sheet) ,  
\* Belzona 9382 (Release Film) ,

**Customer Location:** Western Australia  
**Application Date:** October 2020

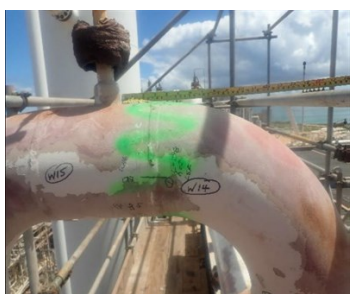
The 250 mm diameter pipe had developed a critical (Class 3) through wall defect at the bent. The operating temperature was 50°C and the operating pressure was 15 bar.

- \* 1. Defect area of the pipe ,
- \* 2. Surface abrasive blasted ,
- \* 3. Application in progress ,
- \* 4. Release Film over the wrap waiting to cure ,
