BELZONA REBUILDS 1.5M DIAMETER CONDENSER FLANGE FACE

Customer Location: Western Australia.
Application Date: May 2018

Exhaust Condenser Flange Rebuild.

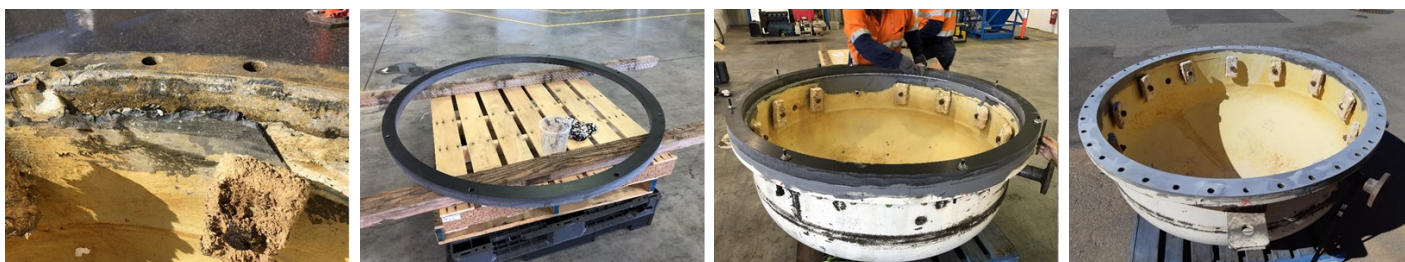
Photograph Descriptions

The previous repair on the Condenser Flange had failed and the customer was fearing that it would start leaking. This would cause unplanned downtime costing thousands of dollars.

- * 1. Close up of the damaged flange. ,
- * 2. 1.5m diameter Flange Former. ,
- * 3. Flange Former bolted in place. ,
- * 4. Completed application. ,

The application was carried out in accordance with Belzona System Leaflet VPF 13 by using a 1.5m diameter, 50mm thick, flat Flange Former coated with Belzona 9411 and left to dry. Belzona 1121 was applied to the flange face and using a plastic applicator with a “V” cut out, was shaped all around with a 6mm high peak in the center. 2mm spacers were placed evenly all round to ensure the Former would sit level when bolted down. 1mm thick Belzona 1121 was then applied to the Former before bringing the two together and bolting up the former. The Belzona 1121 was left overnight to cure before gently removing the Former.
