BELZONA WEATHERPROOFS INSULATED ROOFTOP DUCTING

ID: 861

Customer Location: *Ivy League Medical School*

Application: *HEX-Heat Exchangers*

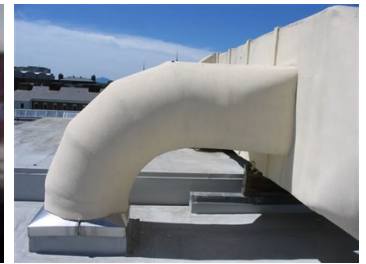
* Degraded insulation on ducts , * Degraded insulation at building interface , * Recoated and protected with Belzona , * Summer 2007 still as good as new! ,

System still excellent 3 years on.
