# BELZONA EXTENDS LIFE OF REDUCTION FLANGE IN CORN MILL

ID: 865

Application: *SHM-Solids Handling Machinery*

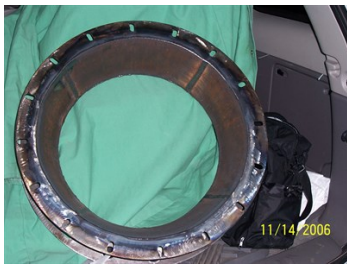
*16" hose reduces to 14" pipe and at this point there is severe wear limiting life to 6 weeks.*

\* Uncoated reduction flange , \* Reduction flange lined with Belzona 1812 , \* Close up of lined flange ,
