BELZONA EXTENDS LIFE OF REDUCTION FLANGE IN CORN MILL

ID: 865

Industry: General Industry
Application: SHM-Solids Handling Machinery

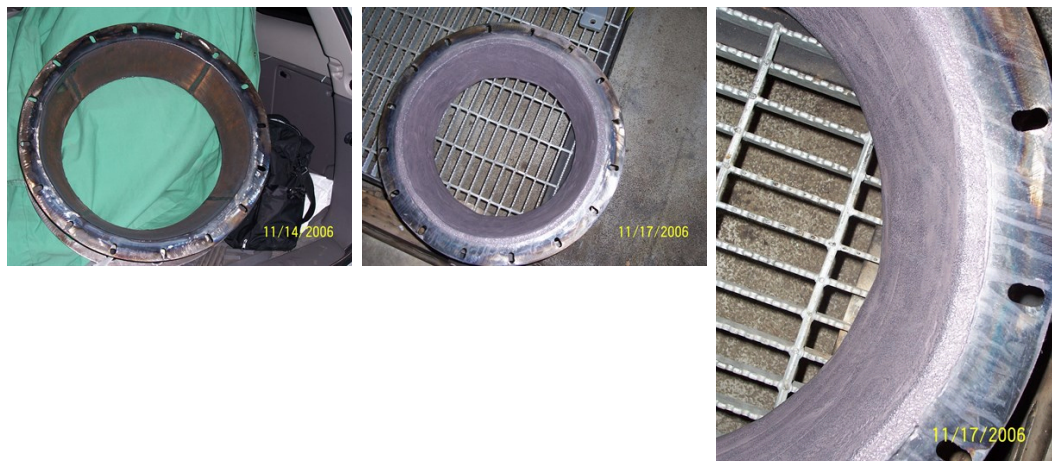
Photograph Descriptions

16" hose reduces to 14" pipe and at this point there is severe wear limiting life to 6 weeks.

* Uncoated reduction flange , * Reduction flange lined with Belzona 1812 , * Close up of lined flange ,

Applicaition was carried out using Belzona System SHM-7.

This extended the life of the flange from 6 weeks to 6 months saving downtime and the expense of having to change it out.
