# BELZONA CONTAINS SULFURIC ACID

**Industry:** Chemical & Petrochemical  
**Application:** TCC-Tanks and Chemical Containment Areas  
**Substrate:** Concrete  
**Products:** Belzona® 4311 (Magma CR-1)<br>Belzona® 4131 (Magma Screed)

**Customer Location:** Ethanol Plant, Iowa, USA  
**Application Date:** April 2007

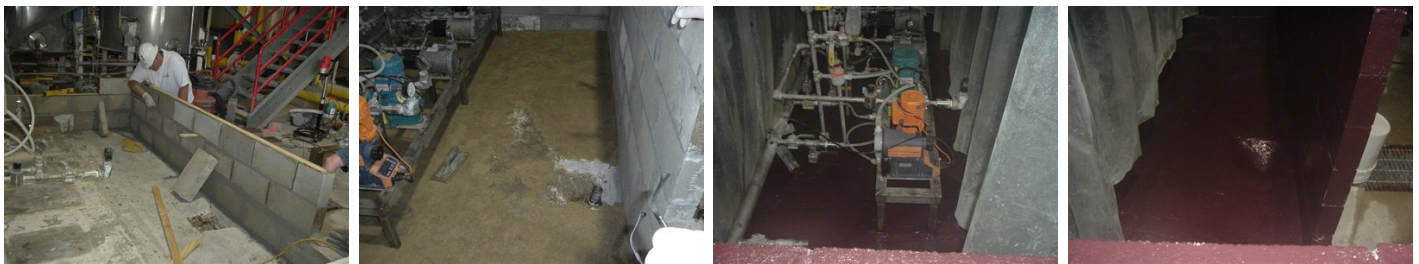
*Sulfuric acid leaks were eroding concrete pump bases as well as floor in small containment area*

\* Concrete block being laid with Belzona® 4131 as mortar , \* Floor sloped to the drain , \* Pumps back in service , \* Completed drain ,

Application was carried out in accordance with modified Belzona System Leaflets TCC-9 & 15. Concrete blocks were laid using Belzona® 4131 as mortar. Floor was re-profiled and sloped so any spill would run towards the drain. The entire floor and walls were coated with Belzona® 4311.
