# Belzona Rebuilds & Protects Beet Washers

ID: 8700

**Industry:** Sugar  
**Application:** GSS-Gaskets, Seals and Shims  
**Substrate:** Cast Iron / Steel  
**Products:** \* Belzona 1111 (Super Metal), ,  
\* Belzona 1812 (Ceramic Carbide FP), ,  
\* Belzona 1321 (Ceramic S-Metal) ,

**Customer Location:** Czech Republic  
**Application Date:** January 2016 (Phase 1)

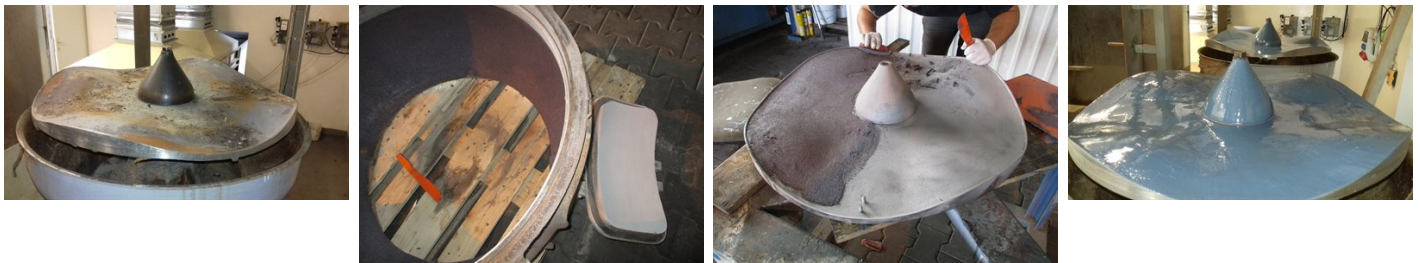
Due to the demanding nature of the sugar beet washers operation - humidity, abrasion and erosion - leading to accelerated rates of corrosion and wear resulting in through wall defects due to repeated abrasion and erosion from the sugar beet during operation.

- \* 1). Deteriated Beet Washers in Situ ,
- \* 2). Partial Belzona 1812 coated Wash Bowl ,
- \* 3). Partial Belzona 1812 coated Lid ,
- \* 4). Top Coated Lid using Belzona 1321 ,

The wash bowl and top lid, were grit blasted prior to being rebuilt to their original profile using Belzona 1111. This was followed by the application of Belzona 1812 which has ceramic fillers inside to reduce and combat the abrasive wear, providing resistance to fine particle abrasion in particular. The bowl and lid were then coated using Belzona 1321 to provide a smoother surface on top of the sacrificial lining. The application was carried out in accordance with Belzona System Leaflet GSS-5 & GSS-9.
