# Apple Cidery Loading Bay Coated with Belzona

Application: FPA-Floor Problem Areas

Renovation of a loading bay at an Apple Cidery.

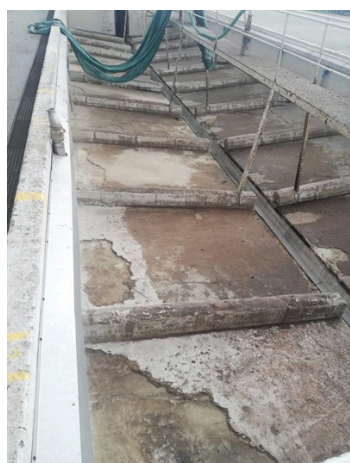
Lorries would arrive on site and dump apples into the loading bay. The juices from the apples were acidic, and over time started to degrade the concrete bay and chemical channel flowing through the bay

- \* 1.) Loading bay prior to application ,
- \* 2.) Surface preparation - Concrete scarifier + UHP ,
- \* 3.) Chemical channel rebuilt with Belzona 4111 + 1st coat of Belzona 5231 being applied ,
- \* 4.) Finished application - 2 coats of Belzona 5231 applied ,
