Belzona Protects Inlet Spools of an Alstom Seawater Pump

Industry: Power
Application: CEP-Centrifugal Pumps
Substrate: Cast Iron
Products: * Belzona 1311 (Ceramic R-Metal) Belzona 9341 (Reinforcement Sheet) Belzona 1321 (Ceramic S-Metal) ,

Customer Location: Jorf Lasfar, Morocco

Application Date: November 2020

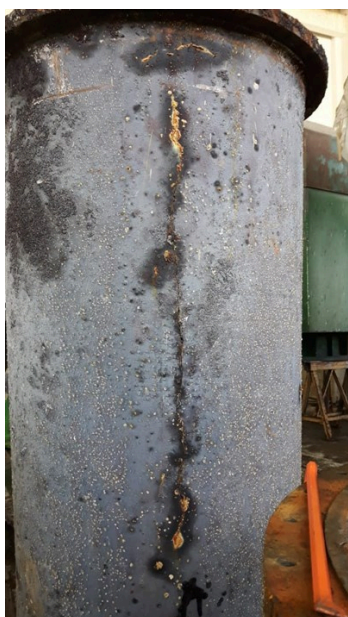
The inlet spool of an Alstom sea pump was cracked (1500mm along the length of the spool) on the outside and suffered corrosion due to sea water, therefore needing to be repaired and protected against future wear along with other parts of the pump.

* 1). Original condition of the Inlet Spool. 2). Surface preparation, termination and V-ing out of the 1500mm crack. 3). Reloading of the inlet spool crack and partial coating application. 4). Completed application overcoated with Belzona 1321. ,
