# Oil Refinery Adopts Belzona Composite Pad for Pipeline Repair

**Industry:** Oil & Gas  
**Application:** VPF-Valves, Pipes and Fittings  
**Substrate:** Steel  
**Products:** \* Belzona SuperWrap II ,  
\* Belzona 1111 (Super Metal) ,

**Customer Location:** Oil Refinery Operator - Australia  
**Application Date:** January 2022

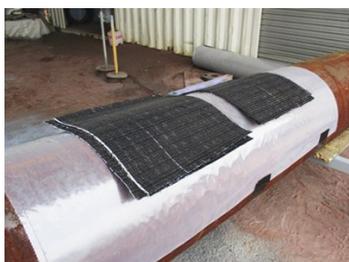
- \* 1. Reinforcement Sheets Cut to Required Size ,
- \* 2. Wetting out Reinforcement Sheets ,
- \* 3. Reinforcement Sheets Applied to Pipe Contour ,
- \* 4. Belzona Composite Pad Bonded to the Pipeline ,

A Belzona SuperWrap II Composite Pad was fabricated to the exact dimensions of the pipe, on-site by qualified SuperWrap II Contractors. The cured Composite Pad was then bonded in place using Belzona 1111 (Super Metal). Due to its lightweight nature, the application could be applied by just two technicians.
