# Belzona seals leaks in clear water storage tank

ID: 8915

Application: TCC-Tanks and Chemical Containment Areas

Substrate: GFRP

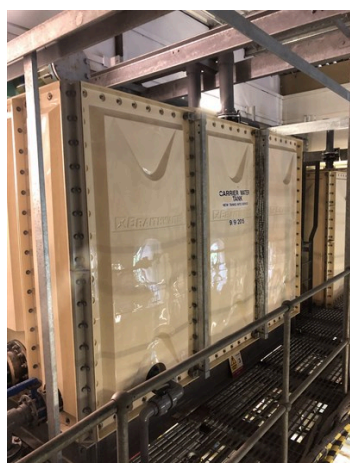
Storage tanks

A clean water storage tank had developed several leaks from the sectional joints that hold the tank together.

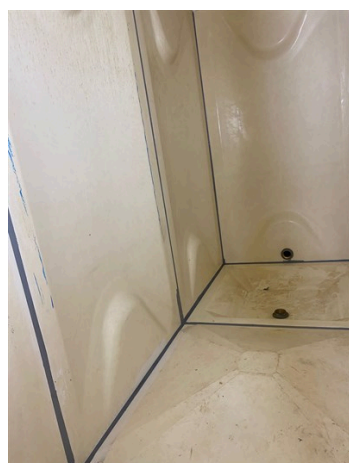
Belzona 1111 applied to fair the gaps between the tank sections

Belzona 1111 Supermetal was applied to fill the gap inbetween the joints. Belzona 1981 with Belzona 9381 was then applied as a band over the joint areas.

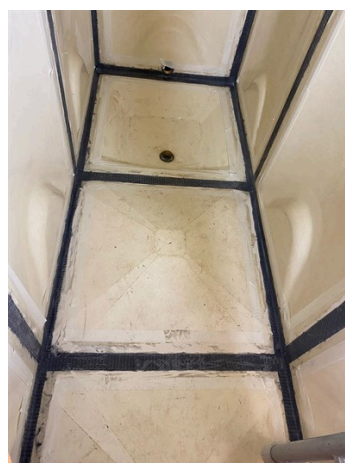
Belzona SuperWrap 2 system applied to the tank joints

The Belzona 1981 SuperWrap II system is able to cope with the movement of the tank during the loading/unloading cycles.

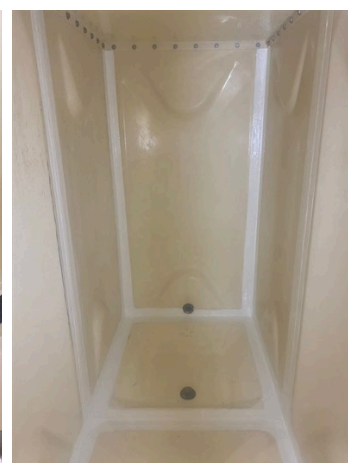
Belzona 5811DW2 applied as a top coat

Two coats of Belzona 5811 DW2 were then applied over the bands to terminate back onto the GRP of the tank.
