Belzona Protects Sulfuric Acid Tank in a Chemical Plant

ID: 8926

Application: TCC-Tanks and Chemical Containment Areas

Application Date: April 2022

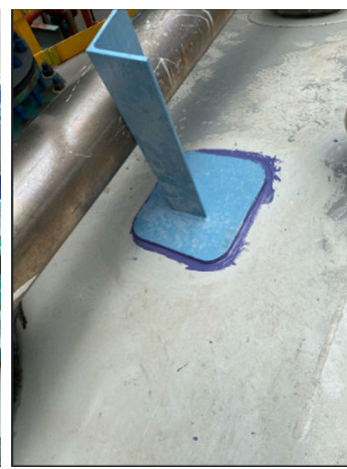
Belzona 7311 to bond pipe supports to the top of the tank.

The tank base was ground, and the previous coating was removed, before Belzona 4911 was used to condition the substrate. Two coats of Belzona 4311 (Magma CR1) were then applied to provide excellent chemical resistance to the tank base. The areas on top of the tank were prepared with a Bristle Blaster to remove paint and to achieve surface roughness to allow pipe supports to be bonded to the top of the tank using Belzona 7311. In total, six 10 inch by 10 inch bottom plates were bonded to tank, initially without additional weight or pressure while the product cured.
