Belzona 1321 Investment Coating for Pump Preservation

ID: 8944

Industry: Water / Wastewater
Application: ENC-Engines and Casings
Substrate: Carbon steel
Products: Belzona 1321 (Ceramic S-Metal)

Customer Location: Birmingham, AL, USA
Application Date: December 2022

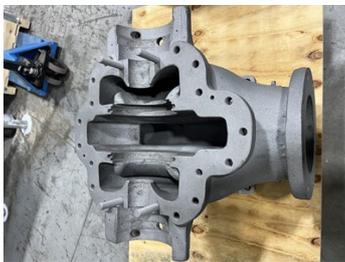
Pump after being sandblasted/prepared.

After receiving the pump following sandblasting, we taped off the casing with duct tape to make a clean edge. We then applied one coat of Belzona 1321 (grey) using short bristled dog leg brushes and followed with a second coat of Belzona 1321 (blue) allowing appropriate cure times and finishes.

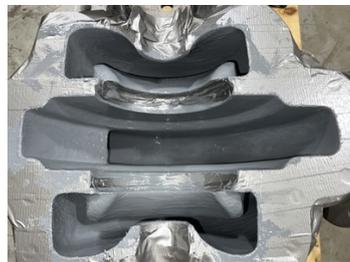
First coat of Belzona 1321 (grey).

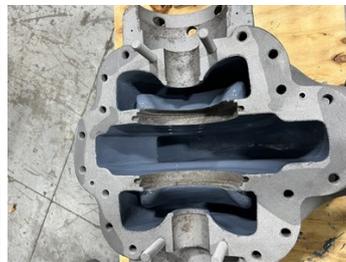
Second Coat of Belzona 1321 (blue).

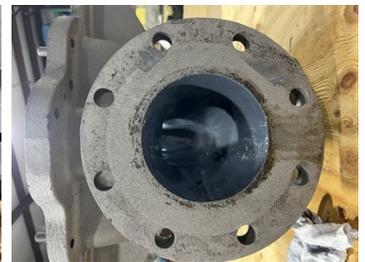
Second view of Belzona 1321's second coat.
