Belzona lines Cooling Pipework for a large Steel Manufacturer

ID: 8993

Industry: *Steel & Metal Processing*
Application: *VPF-Valves, Pipes and Fittings*
Substrate: *Carbon steel*
Products: *Belzona 5811 (Immersion Grade)*

Customer Location: *Normande, France*
Application Date: *November 2020*

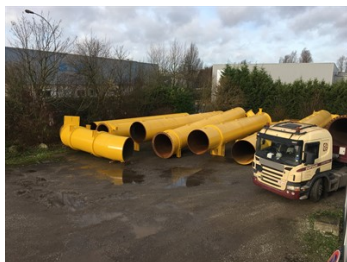
The cooling pipework had suffered corrosion due to course and seawater being used as the cooling fluid.

Pipework pre-refurbishment.

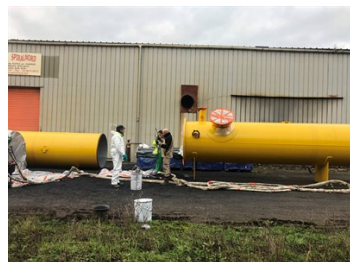
Pipework mid-application of Belzona 5811.

The distributor applied Belzona 5811 by Airless Spraying to increase application speed and provide a more even DFT. The application was carried out in accordance with a modified version of Belzona System Leaflet VPF-02.

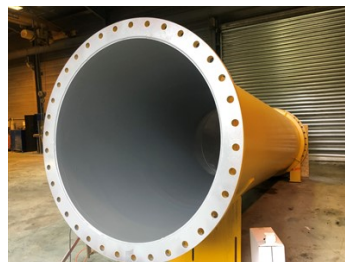
Finished internal & external lining application using Belzona 5811.

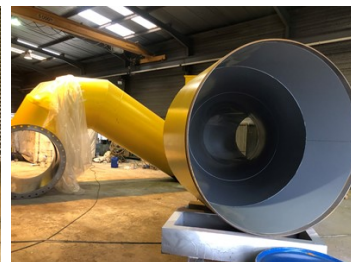
Finished internal & external lining application using Belzona 5811.
