Belzona lines Cooling Pipework for a large Steel Manufacturer

ID: 8993

Industry: Steel & Metal Processing
Application: VPF-Valves, Pipes and Fittings
Substrate: Carbon steel
Products: Belzona 5811 (Immersion Grade)

Customer Location: Normande, France
Application Date: November 2020

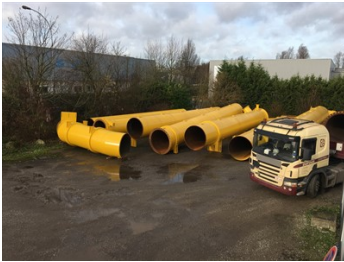
The cooling pipework had suffered corrosion due to course and seawater being used as the cooling fluid.

Pipework pre-refurbishment.

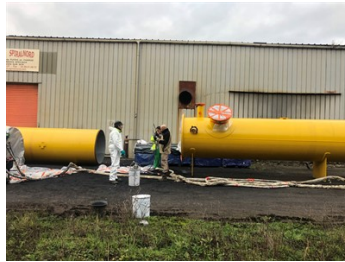
Pipework mid-application of Belzona 5811.

The distributor applied Belzona 5811 by Airless Spraying to increase application speed and provide a more even DFT. The application was carried out in accordance with a modified version of Belzona System Leaflet VPF-02.

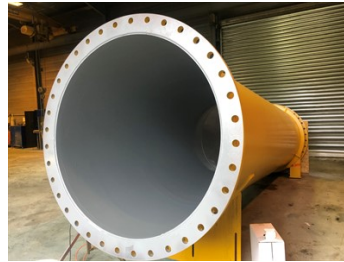
Finished internal & external lining application using Belzona 5811.

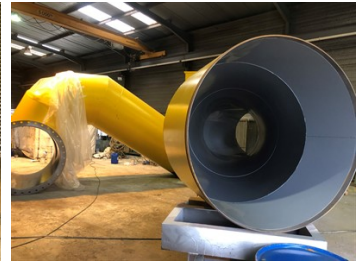
Finished internal & external lining application using Belzona 5811.
