Belzona lines Cooling Pipework for a large Steel Manufacturer

ID: 8993

Industry: Steel & Metal Processing
Application: VPF-Valves, Pipes and Fittings
Substrate: Carbon steel
Products: Belzona 5811 (Immersion Grade)

Customer Location: Normande, France
Application Date: November 2020

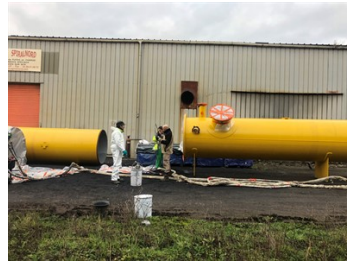
Pipework mid-application of Belzona 5811.

The distributor applied Belzona 5811 by Airless Spraying to increase application speed and provide a more even DFT. The application was carried out in accordance with a modified version of Belzona System Leaflet VPF-02.

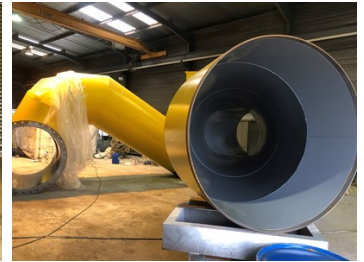
Finished internal & external lining application using Belzona 5811.
