Coal Silo Flopgate

ID: 8998

Industry: *Mining & Quarrying*
Application: *SHM-Solids Handling Machinery*

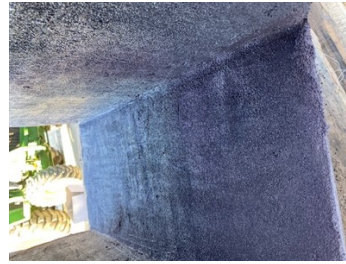
New chute coated with Belzona Ceramic Carbide FP (1812)

Chutes and flopgate valve were abrasion blasted. Blasted area was then cleaned using Belzona 9111. Belzona 1812 was applied using an applicator at 1/4" thickness.

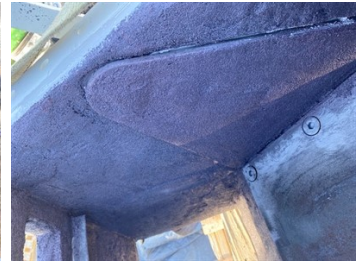
New flopgate coated with Belzona Ceramic Carbide FP (1812)
