Coal Silo Flopgate

ID: 8998

Industry: *Mining & Quarrying*
Application: *SHM-Solids Handling Machinery*

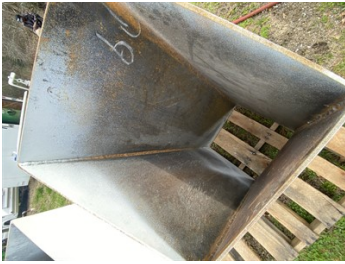
New chute pre-coating

Chutes and flopgate valve were abrasion blasted. Blasted area was then cleaned using Belzona 9111. Belzona 1812 was applied using an applicator at 1/4" thickness.

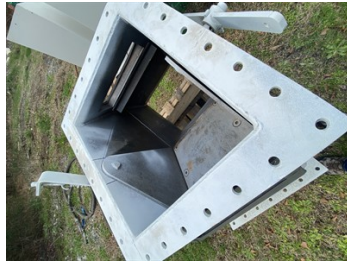
New Flopgate pre-coating

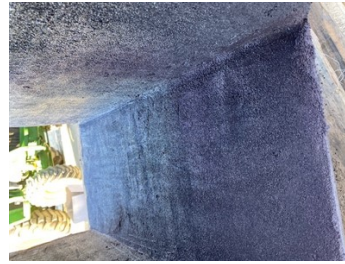
New chute coated with Belzona Ceramic Carbide FP (1812)

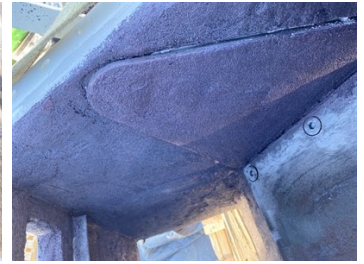
New flopgate coated with Belzona Ceramic Carbide FP (1812)
