Protecting a Pipe Spool

ID: 8999

Industry: Pulp & Paper
Application: VPF-Valves, Pipes and Fittings
Substrate: Stainless-steel
Products: Belzona 4301 (Magma CR1 Hi-Build)

Customer Location: South Carolina, USA
Application Date: August 2022

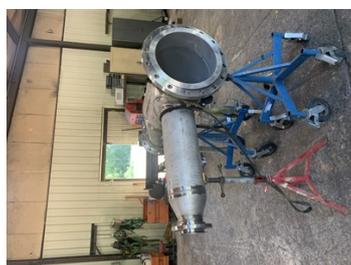
Pipe spool with interior pipes blasted to attain proper surface preparation.

After blasting, we applied Belzona 4301 using brushes. It was tricky in some of the smaller pipe areas of the spool, but we were able to get a good application on the entire internal pipe spool. We inspected the areas thoroughly after the application.

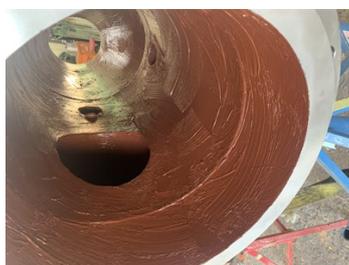
Interior of pipe spool with Belzona 4301 applied.

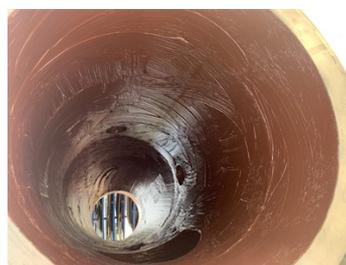
Different view of the interior of the pipe spool after applying Belzona 4301.

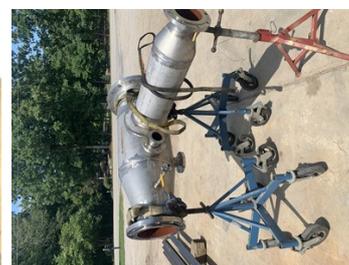
Finished product curing in the South Carolina August Sun.
