Belzona Helps Extend Dredge Pump Run Time

ID: 9029

Industry: Marine
Application: CEP-Centrifugal Pumps
Substrate: Other
Products: Belzona 1331, Belzona 1814

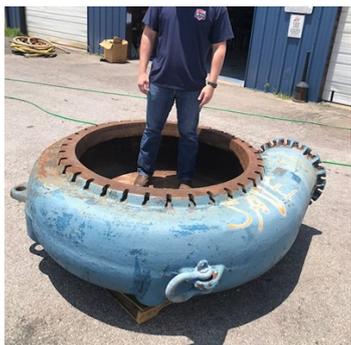
Large Pumps Arrive at the shop for coating

Pump was brought to the shop

SP10 minimum 3-mil blast

"Priming" coat of 1331 was applied to help with increasing shear adhesion of the 1814

1/4" of 1814 applied to the entire pump internals.

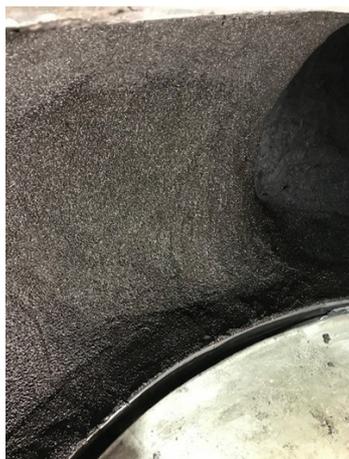
Belzona 1814 applied inside

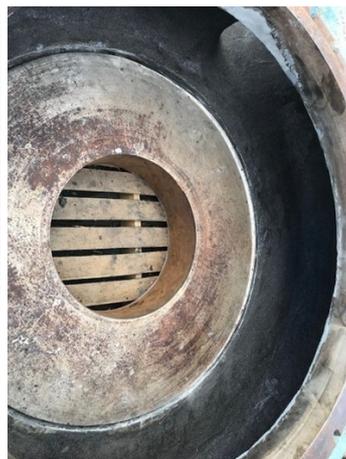
Belzona 1814 applied to all wear areas of the pump
