Belzona protects 98% sulphuric acid chemical containment area

Industry: *Chemical & Petrochemical*
 Application: *TCC-Tanks and Chemical Containment Areas*
 Substrate: *Concrete*
 Products: *Belzona 4311 (Magma CR1)*

Customer Location: *Croatia*
 Application Date: *June 2009*

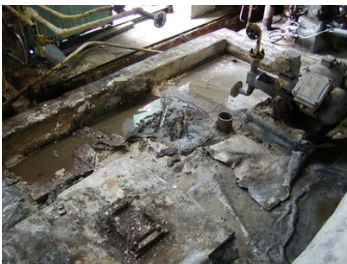
Chemical containment area protected by lead cover failed.

Damaged chemical containment area

Application was carried out in accordance with TCC-15. Concrete under the lead cover needed to be rebuilt with new concrete with chemical resistant tiles and protected with Belzona 4311.

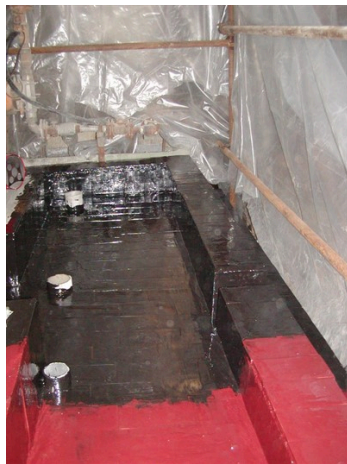
Protection of chemical containment area in progress

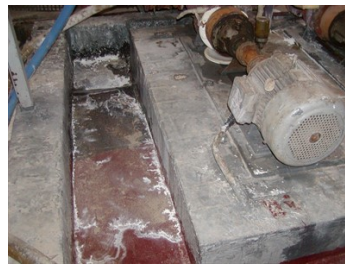
No deterioration shown after 5 years

After 5 years in service Belzona showed no deterioration.

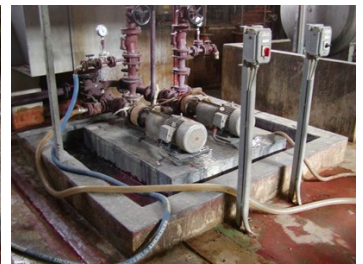
No deterioration shown after 5 years
