Belzona Provides Economical Coating for Large Cooling Water Impeller

ID: 9042

Industry: Oil & Gas
Application: CEP-Centrifugal Pumps
Substrate: Cast Iron
Products: Belzona 5821

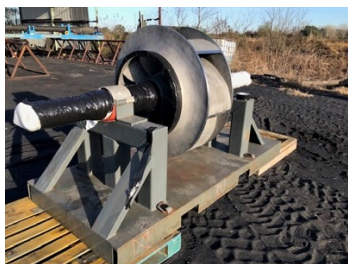
Impeller prior to the application

Pump was delivered to shop

Blasted to SP10 minimum 3 mil profile per the IFU

Two coats of Belzona 5821 were applied to the impeller wet areas.

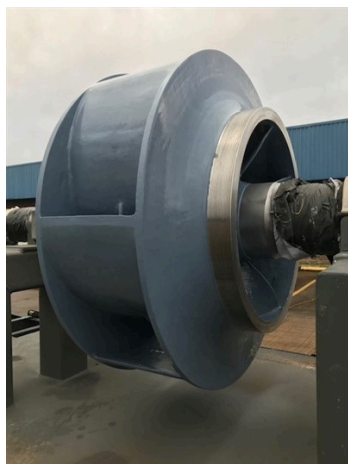
Completed application
