# Belzona Provides Economical Coating for Large Cooling Water Impeller

ID: 9042

Industry: Oil & Gas  
Application: CEP-Centrifugal Pumps  
Substrate: Cast Iron  
Products: Belzona 5821

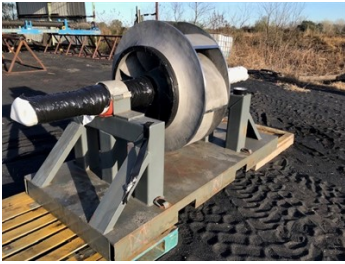
*The client wanted a coating to protect their impeller but was on a tight budget for the project. A cost-effective alternative was needed.*

Impeller prior to the application

Pump was delivered to shop

Blasted to SP10 minimum 3 mil profile per the IFU

Two coats of Belzona 5821 were applied to the impeller wet areas.

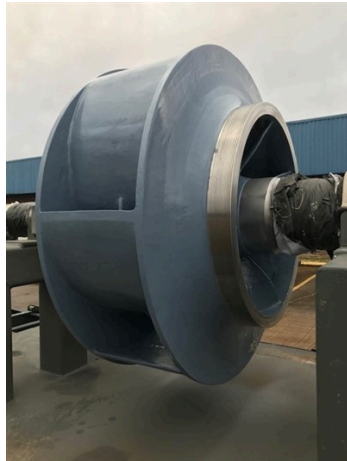
Completed application
