Belzona 1593 protects critical areas in 15 storage tanks

ID: 9052

Customer Location: Rotterdam Botlek
Application Date: June 2022

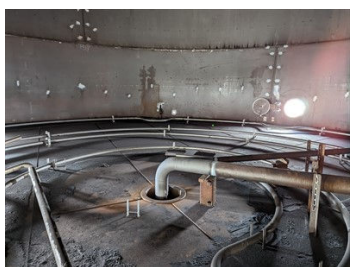
Before application

Substrate was masked and grit blasted. The profile was measured and well above 75um. After stripe coating on the welds and corners, two layers of Belzona 1593 were applied by brush and applicator. For each tank a test panel was made and tested for adhesion. All test panels were tested with dolly pull-off.

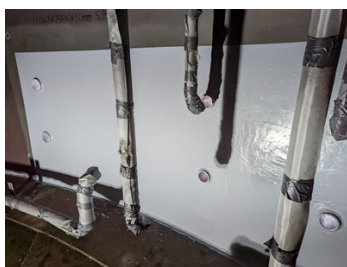
First layer Belzona 1593 at the coil inlet

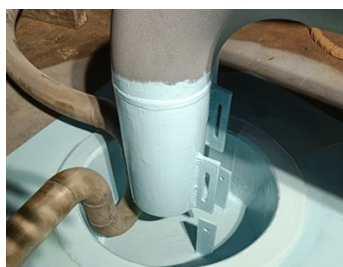
Two layers Belzona 1593 in the sump

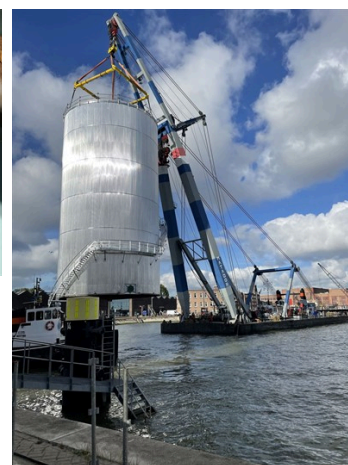
Tanks are shipped to tankpark
