Belzona 1593 protects critical areas in 15 storage tanks

ID: 9052

Industry: Chemical & Petrochemical
Application: TCC-Tanks and Chemical Containment Areas
Substrate: Carbon steel
Products: Belzona 1593

Customer Location: Rotterdam Botlek
Application Date: June 2022

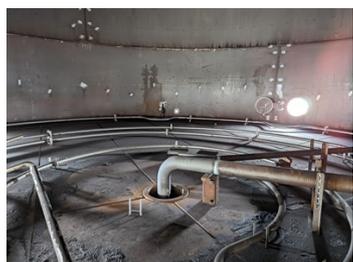
Before application

Substrate was masked and grit blasted. The profile was measured and well above 75um. After stripe coating on the welds and corners, two layers of Belzona 1593 were applied by brush and applicator. For each tank a test panel was made and tested for adhesion. All test panels were tested with dolly pull-off.

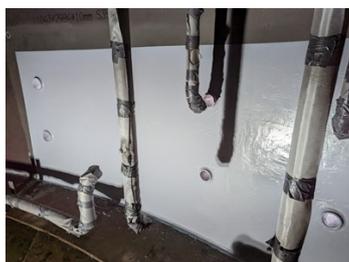
First layer Belzona 1593 at the coil inlet

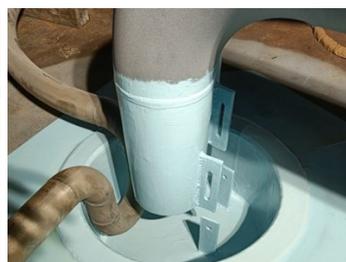
Two layers Belzona 1593 in the sump
