Belzona SuperWrap II secures integrity of pipeline

ID: 9054

Industry: Chemical & Petrochemical
Application: VPF-Valves, Pipes and Fittings
Substrate: Carbon steel
Products: Belzona 1983 (SuperWrap II)

Customer Location: Rotterdam
Application Date: March 2023

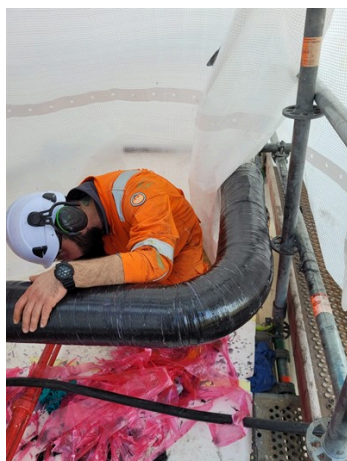
After curing removing the Belzona 9382 tape to inspect the application

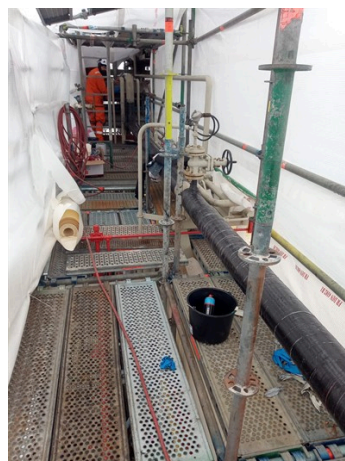
First 5 meters of Belzona SuperWrap completed. 35 meter to go.

To bring strength back to this pipe we offered a Belzona SuperWrap II. No leaks were detected, so Belzona SuperWrap was applied directly on the hot pipe at 30 degrees Celcius. A small landing area was created on both ends of the wrap, so it would have a good adhesion. In total 3 layers were applicated on the straight parts and 6 layers on the corners.
