Belzona SuperWrap II secures integrity of pipeline

ID: 9054

Industry: Chemical & Petrochemical
Application: VPF-Valves, Pipes and Fittings
Substrate: Carbon steel
Products: Belzona 1983 (SuperWrap II)

Customer Location: Rotterdam
Application Date: March 2023

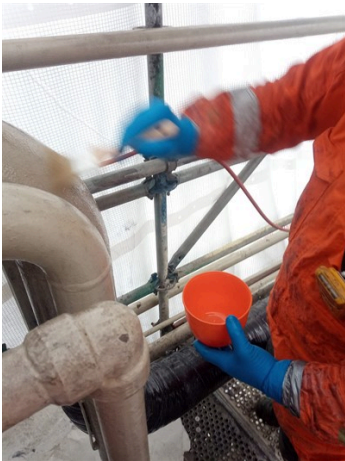
Surface preparation. A thin layer of Belzona 1983 onto the pipe.

To bring strength back to this pipe we offered a Belzona SuperWrap II. No leaks were detected, so Belzona SuperWrap was applied directly on the hot pipe at 30 degrees Celcius. A small landing area was created on both ends of the wrap, so it would have a good adhesion. In total 3 layers were applicationed on the straight parts and 6 layers on the corners.

At critical area's like support's and flanges the area was grinded with MBX Bristle Blaster. Also the landing area's (300 mm wide) were prepared with MBX Bristle Blasters (ATEX).

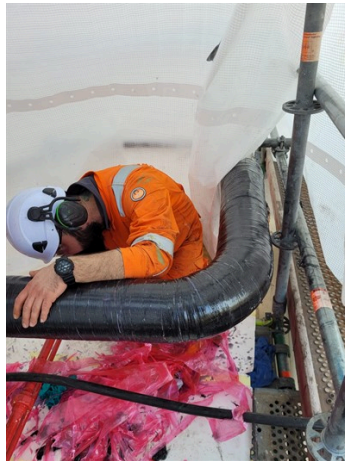
After curing removing the Belzona 9382 tape to inspect the application

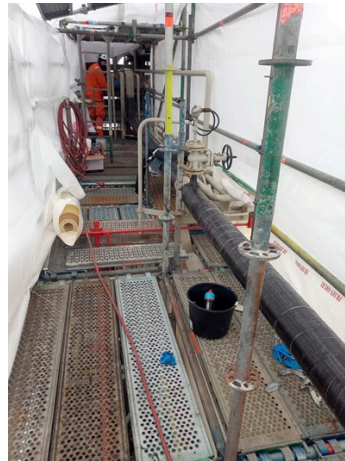
First 5 meters of Belzona SuperWrap completed. 35 meter to go.

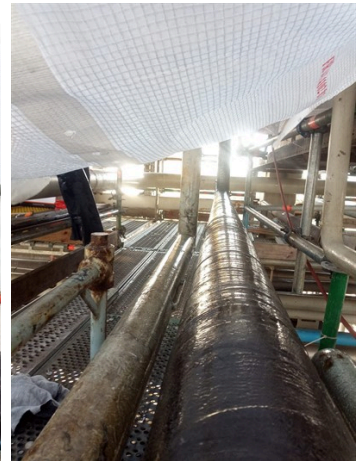
Finished application halfway the pipe.

In total 30 meters of pipeline was wrapped by the Super Wrap II
The integrity op this pipeline is reassured without any downtime and production stop.
