# Belzona SuperWrap II System Saves 120k

Industry: Oil & Gas  
Application: VPF-Valves, Pipes and Fittings  
Substrate: Cast Iron  
Products: Belzona 1982 (SuperWrap II), Belzona 4141 (Magma-Build)

Customer Location: Delhi, LA, USA  
Application Date: October 2022

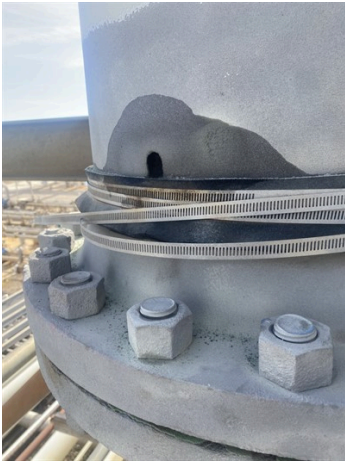
The customer had a clamp previously put on a hole in the condensate line. The clamp started leaking and they were going to replace them at this time.

Line clamp leaking.

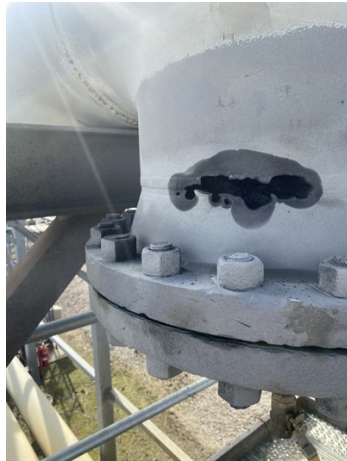
Clamp removed and vapor blaster used.

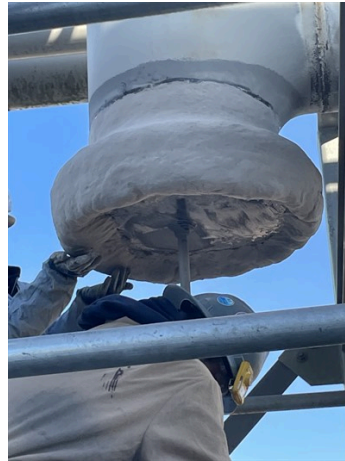
Encapsulation of entire head.

Belzona 4141 was used to encapsulate the holes and then Belzona SuperWrap II system (with Belzona 1982 resin) was used to provide structural integrity to the asset.

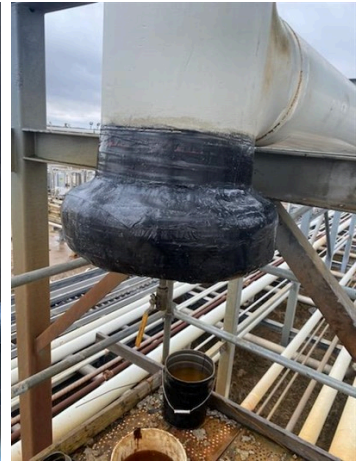
Finalized SuperWrap II application.
