Belzona SuperWrap II System Saves 120k

ID: 9078

Application: VPF-Valves, Pipes and Fittings

Products: Belzona 1982 (SuperWrap II), Belzona 4141 (Magma-Build)

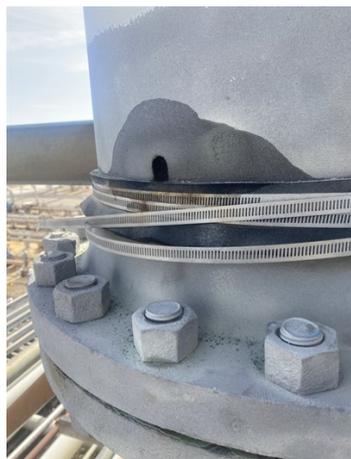
The customer had a clamp previously put on a hole in the condensate line. The clamp started leaking and they were going to replace them at this time.

Line clamp leaking.

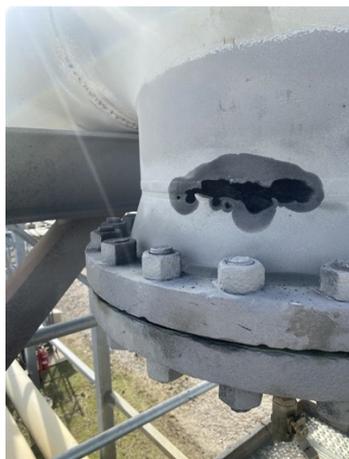
Clamp removed and vapor blaster used.

Belzona 4141 was used to encapsulate the holes and then Belzona SuperWrap II system (with Belzona 1982 resin) was used to provide structural integrity to the asset.

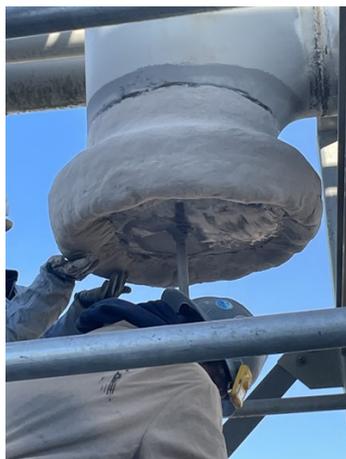
Encapsulation of entire head.

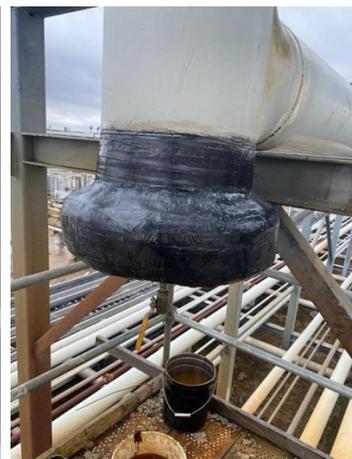
Finalized SuperWrap II application.
