Belzona Provides Anti-Cavitation Resistance to Drive Shaft

ID: 9116

Industry: *Marine*
Application: *SOS-Ships and Offshore Structures*

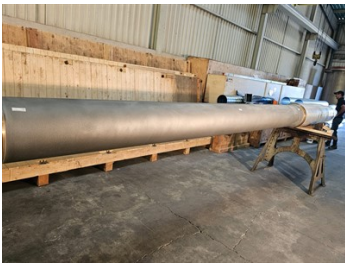
1.) Driveshaft after grit blasting 2.) 2 coats of Belzona 1341 applied

This application was carried out in accordance with adapted versions of system leaflets SOS-6 & SOS-2. First, the drive shaft was grit blasted to SA2.5, achieving a 75-micron profile. After surface preparation, any required areas were rebuilt with Belzona 1311 before 2 coats of Belzona 1341 were applied. Finally, Belzona 2941 conditioner was applied before 2 coats of Belzona 2141.

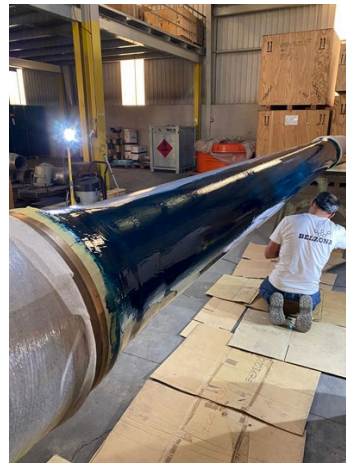
3.) 1st coat of Belzona 2141 being applied

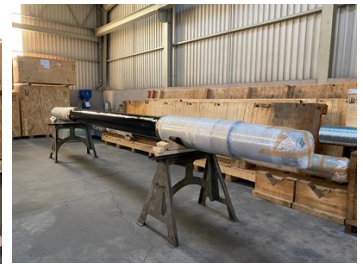
4.) Final application - 2 coats of Belzona 2141
