Belzona Protects a Screw Conveyor within a Petrochemical Refineries' Wastewater Facility.

ID: 9117

Industry: Chemical & Petrochemical
Application: SHM-Solids Handling Machinery

Customer Location: Rouen, France
Application Date: August 2022

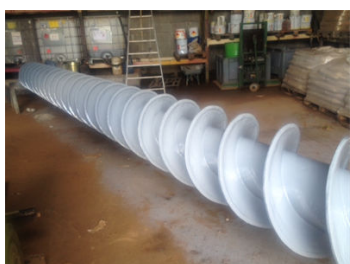
Screw during the Belzona 1341 application.

The screw trough was coated using Belzona 5811, an immersion-grade epoxy barrier coating, prior to being overcoated by black paint for aesthetics. The screw was also coated with an epoxy coating Belzona 1341, however, the latter is designed to increase the efficiency and reduce waste material drag. The application was carried out in accordance with Belzona System Leaflet SMH-14.

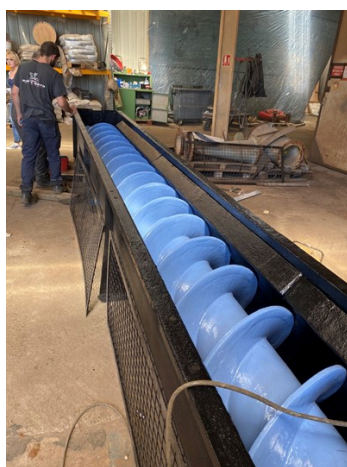
Screw & trough once completed.

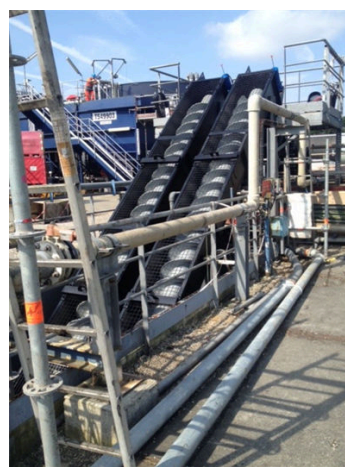
Screw & trough once put back into service.
