# Belzona Protects a Screw Conveyor within a Petrochemical Refineries' Wastewater Facility.

ID: 9117

Industry: Chemical & Petrochemical  
Application: SHM-Solids Handling Machinery

Substrate: Carbon steel  
Products: Belzona 1341 (Supermetalglide), Belzona 5811 (Immersion Grade)

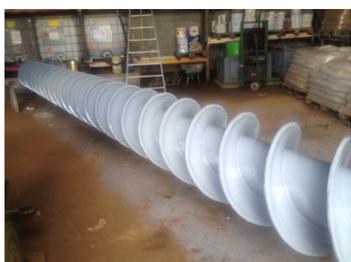
Screw during the Belzona 1341 application.

The screw trough was coated using Belzona 5811, an immersion-grade epoxy barrier coating, prior to being overcoated by black paint for aesthetics. The screw was also coated with an epoxy coating Belzona 1341, however, the latter is designed to increase the efficiency and reduce waste material drag. The application was carried out in accordance with Belzona System Leaflet SMH-14.

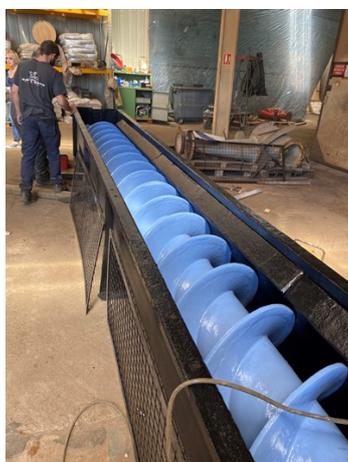
Screw & trough once completed.

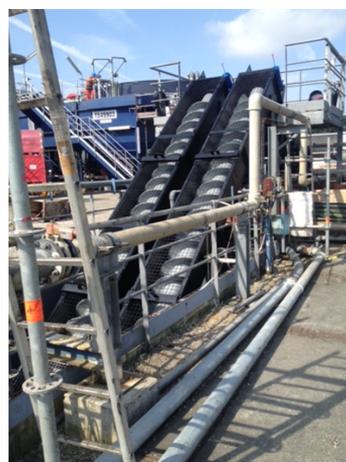
Screw & trough once put back into service.
