Bund cover plates receive Belzona acid protection

ID: 9142

Industry: Marine
Application: TCC-Tanks and Chemical Containment Areas
Substrate: Carbon steel
Products: Belzona 4351 (Magma CR5)

Customer Location: Derby
Application Date: October 2023

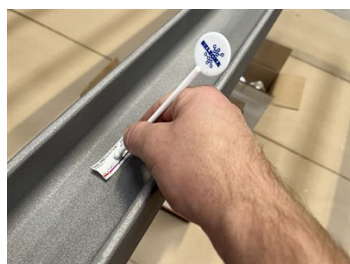
Blasted to SA 2.5 and 75 microns minimum

Grit blasting carried out in our internal Blast-booth to SA2.5 and 75 microns (minimum)

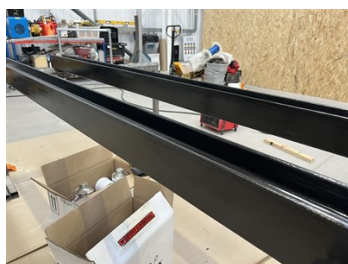
Belzona 4351 (Magma CR5) applied to supporting beams

2 coats of Belzona 4351 (Magma CR5) were applied as per IFU at 250 microns

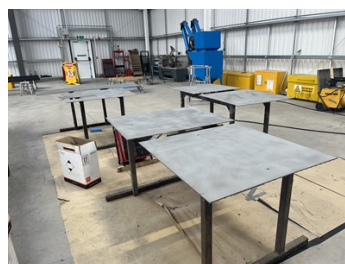
Cover plates prepared as per Belzona 4351 (Magma CR5) IFU

All steelwork cleaned and degreased

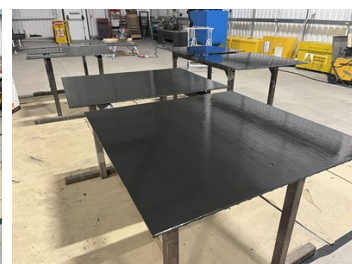
All steel work protection completed.
