# Belzona Protects Pipelines on Offshore Platform

ID: 9166

Industry: Marine  
Application: VPF-Valves, Pipes and Fittings  
Substrate: Carbon steel  
Products: Belzona 1331

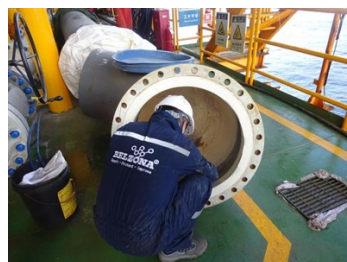
Belzona 1331 is being sprayed inside the pipeline

Application was carried out with an adapted version of Belzona System Leaflet VPF-02. The inner linings of pipes and elbows are applied with Belzona products using spraying guns and brushes.

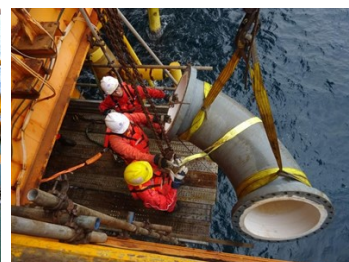
Spraying application completed
