# BELZONA ENCAPSULATES FLAT ROOF AND PARAPET WALLS

ID: 919

**Customer Location:** Logistics Factory, Lancashire - UK  
**Application Date:** April 2007

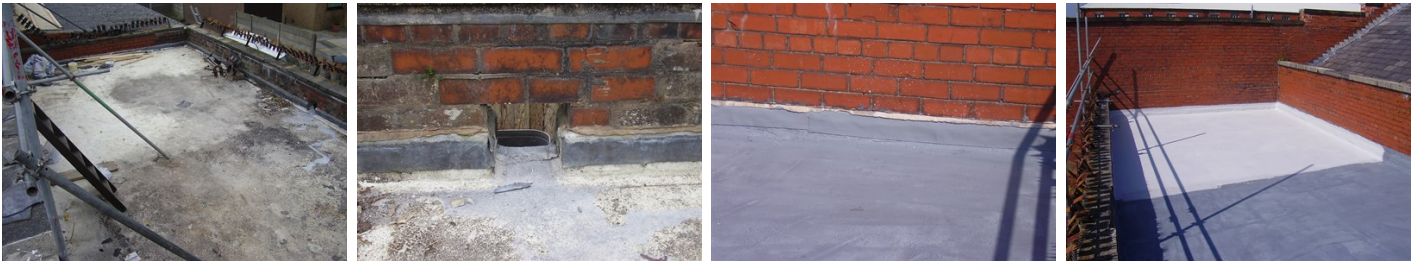
*Deterioration of original felt finish had allowed water ingress into the roof deck. In particular the felt had split and cracked in critical areas such as the wall to roof interface and the water outlets.*

- \* Roof area prior to coating ,
- \* Close up of parapet wall and gutter outlet ,
- \* Belzona® 3111 encapsulating roof deck and parapet wall ,
- \* Completed Belzona® 3111 reinforced system ,

The application was carried out in accordance with Belzona Know-How system leaflets RPA-6, RPA-8, and RPA-10.
