Reinforcement of an Ammonia Tank using Belzona SW2.

ID: 9215

Customer Location: St Nazaire, France

Application: TCC-Tanks and Chemical Containment Areas

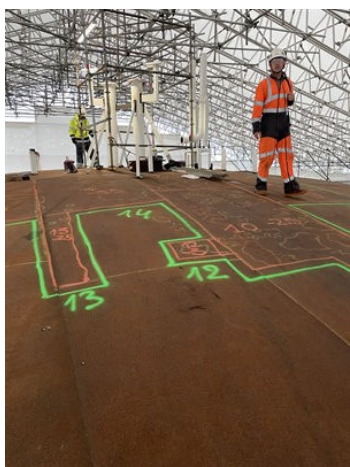
Roof prior to the application.

The roof of an Ammonia (NH₃) tank showed signs of weakening due to prolonged corrosion. In order to restore structural integrity, we'll be reinforcing localised parts of the roof from the exterior of the tank using Belzona SuperWrap II. This repair will allow to restore the tanks compliance without the need for welding new plates, risking making the structure heavier.

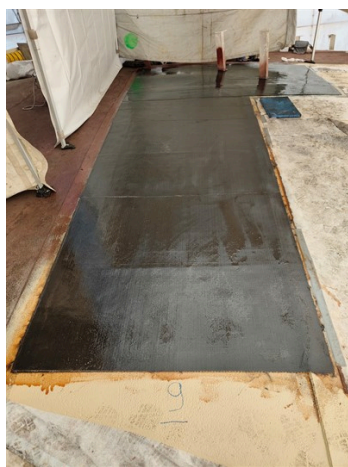
Application of the first layer.

To restore the damaged areas, we first needed to pit-fill to the exact profile of the original roof using Belzona 1121. Then, to reinforce the areas in need of repair we conducted SuperWrap II patch repairs. Finally, to provide anti-corrosion assurance we applied corrosion barrier coating, Belzona 5831LT.

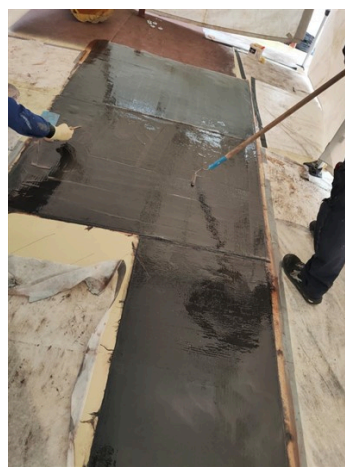
Utilisation of a roller between each layer to remove bubbles and consolidate.

This application followed a modified version of Belzona System Leaflets, with an adaption due to the fact we can't use Belzona 9382 (Release/Consolidation Film). We therefore had to use rollers to compress (removing air bubbles) and consolidate between each layer (applied 4x layers at 90°).

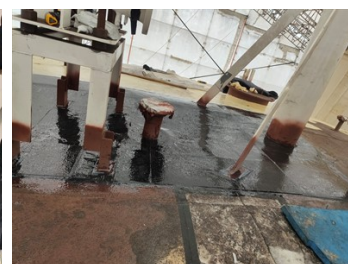
Reinforcement application completed prior to the application of Belzona 5831 LT.
