# Reinforcement of an Ammonia Tank using Belzona SW2.

ID: 9215

Application: TCC-Tanks and Chemical Containment Areas

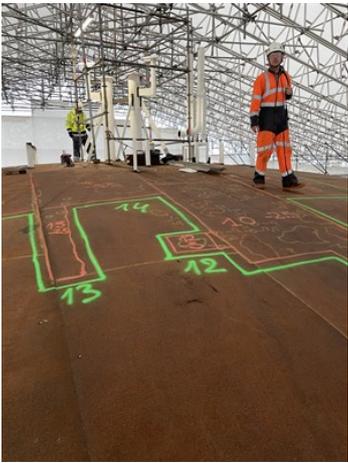
Roof prior to the application.

The roof of an Ammonia (NH3) tank showed signs of weakening due to prolonged corrosion. In order to restore structural integrity, we'll be reinforcing localised parts of the roof from the exterior of the tank using Belzona SuperWrap II. This repair will allow to restore the tanks compliance without the need for welding new plates, risking making the structure heavier.

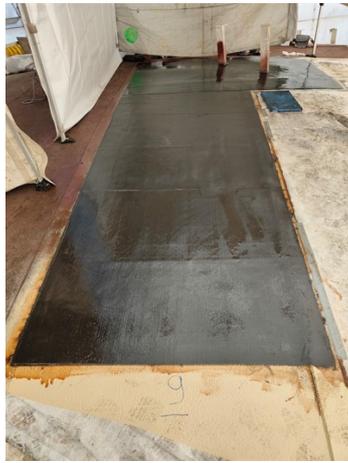
Application of the first layer.

To restore the damaged areas, we first needed to pit-fill to the exact profile of the original roof using Belzona 1121. Then, to reinforce the areas in need of repair we conducted SuperWrap II patch repairs. Finally, to provide anti-corrosion assurance we applied corrosion barrier coating, Belzona 5831LT.

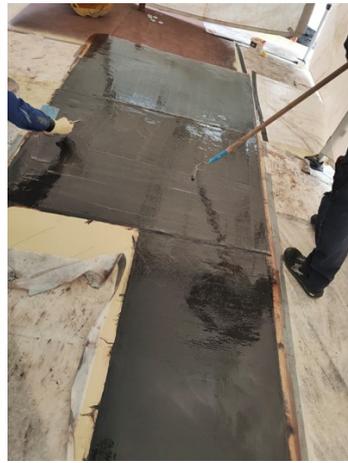
Utilisation of a roller between each layer to remove bubbles and consolidate.

This application followed a modified version of Belzona System Leaflets, with an adaptation due to the fact we can't use Belzona 9382 (Release/Consolidation Film). We therefore had to use rollers to compress (removing air bubbles) and consolidate between each layer (applied 4x layers at 90°).

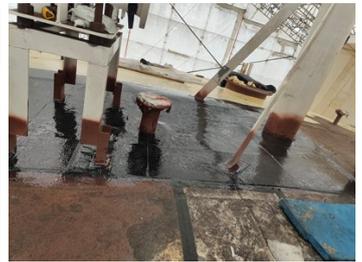
Reinforcement application completed prior to the application of Belzona 5831 LT.
