# Reinforcement of an Ammonia Tank using Belzona SW2.

ID: 9215

Industry: Chemical & Petrochemical

Customer Location: St Nazaire, France

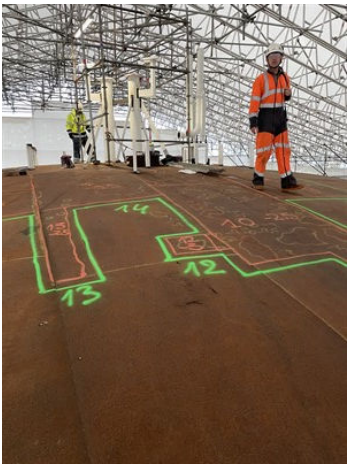
The roof of an Ammonia (NH3) tank showed signs of weakening due to prolonged corrosion. In order to restore structural integrity, we'll be reinforcing localised parts of the roof from the exterior of the tank using Belzona SuperWrap II. This repair will allow to restore the tanks compliance without the need for welding new plates, risking making the structure heavier.

Roof prior to the application.

To restore the damaged areas, we first needed to pit-fill to the exact profile of the original roof using Belzona 1121. Then, to reinforce the areas in need of repair we conducted SuperWrap II patch repairs. Finally, to provide anti-corrosion assurance we applied corrosion barrier coating, Belzona 5831LT.

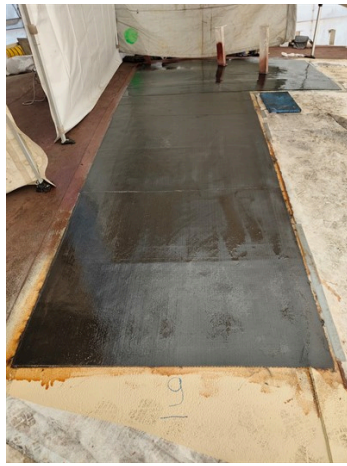
Application of the first layer.

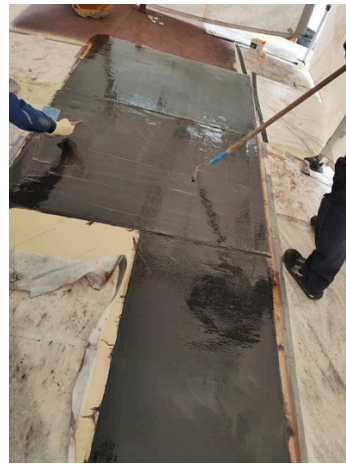
Utilisation of a roller between each layer to remove bubbles and consolidate.

This application followed a modified version of Belzona System Leaflets, with an adaptation due to the fact we can't use Belzona 9382 (Release/Consolidation Film). We therefore had to use rollers to compress (removing air bubbles) and consolidate between each layer (applied 4x layers at 90°).

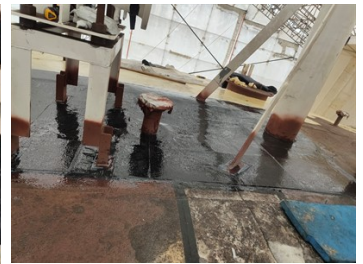
Reinforcement application completed prior to the application of Belzona 5831 LT.
