Handrail bonding on offshore deck

ID: 9253

Industry: Oil & Gas
Application: GSS-Gaskets, Seals and Shims
Substrate: Carbon steel
Products: Belzona 1161 (Super UW-Metal), Belzona 5811 (Immersion Grade), Belzona 7311

Customer Location: Offshore
Application Date: July 2023

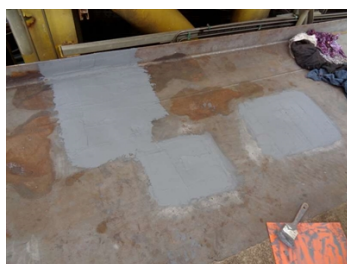
Fixing the holes with Belzona 1161 and re-inforcement sheets

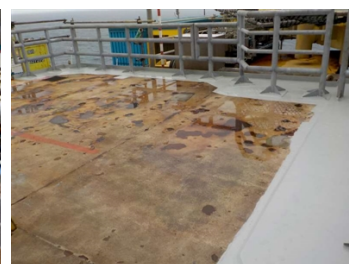
Application ready to be top coated.
