# Handrail bonding on offshore deck

ID: 9253

Industry: Oil & Gas

Application: GSS-Gaskets, Seals and Shims

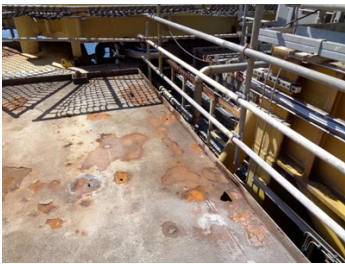
A new handrail was designed on an offshore loading deck just above critical lower deck. Because there were some holes in the deck due to corrosion, welding new plates was not clients first choice. A very strong bonding was required and had to be designed and calculated. Also the flexibility of the Belzona 7311 was preferable because large containers could impact into the handrail.

Deck before application

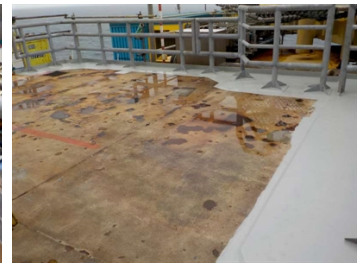
Application ready to be top coated.
