REGULAR BELZONA SUPERWRAP II ON LOW SPECIFICATION PIPING SYSTEMS

ID: 9263

Industry: Oil & Gas
Application: VPF-Valves, Pipes and Fittings
Substrate: Carbon steel
Products: Belzona 1111 (Super Metal), Belzona 1161 (Super UW-Metal), Belzona 1981 (SuperWrap II)

Customer Location: North Sea Norway
Application Date: December 2022

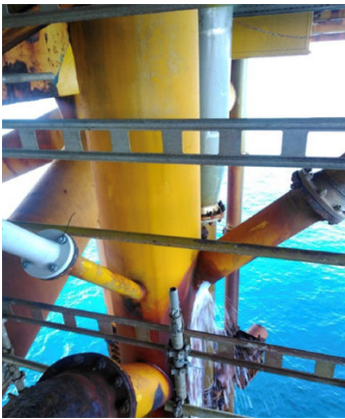
Due to years of neglected priority of maintenance, the client was experiencing severe corrosion challenges on their low-specification piping systems. This meant they were now facing a costly and time-consuming replacement of large sections of important equipment.

Severe corrosion on 24" caisson.

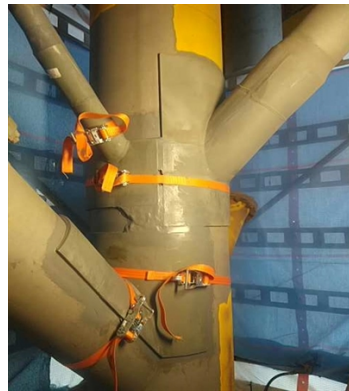
Bonding custom made reinforcement plates.

Custom made 10mm doublerplates was bonded over severely corroded areas to add structural strength and extended wallthickness to the piping system.

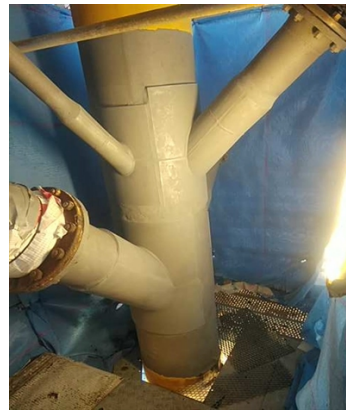
Preparing for SuperWrap II Application

After full cure of the bonding application the surface was grit blasted a second time and prepared for a designed Belzona SuperWrap II application.
