REGULAR BELZONA SUPERWRAP II ON LOW SPECIFICATION PIPING SYSTEMS

ID: 9263

Customer Location: North Sea Norway
Application Date: December 2022

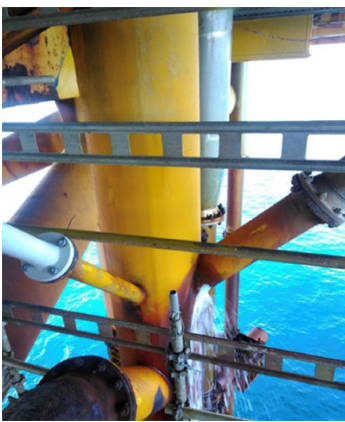
Due to years of neglected priority of maintenance, the client was experiencing severe corrosion challenges on their low-specification piping systems. This meant they were now facing a costly and time-consuming replacement of large sections of important equipment.

Severe corrosion on 24" caisson.

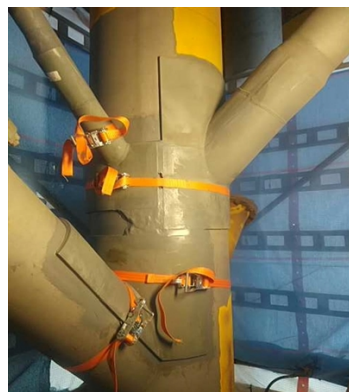
Bonding custom made reinforcement plates.

Custom made 10mm doublerplates was bonded over severely corroded areas to add structural strength and extended wallthickness to the piping system.

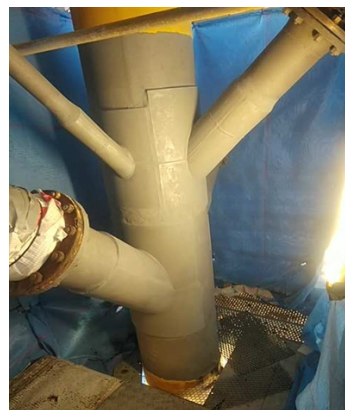
Preparing for SuperWrap II Application

After full cure of the bonding application the surface was grit blasted a second time and prepared for a designed Belzona SuperWrap II application.
