Belzona Protects New Pumps with Anti-corrosion Coating with Drinking Water Safety Certificate

Industry: Fluid Flow
Application: CEP-Centrifugal Pumps
Substrate: Cast Iron
Products: Belzona 5811DW2 (DW Immersion Grade)

Customer Location: Jiangsu, China 中国
Application Date: May 2017

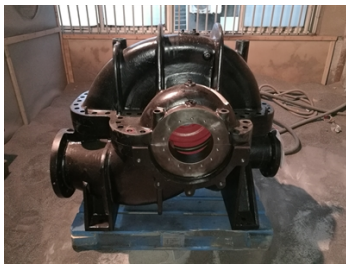
Before application

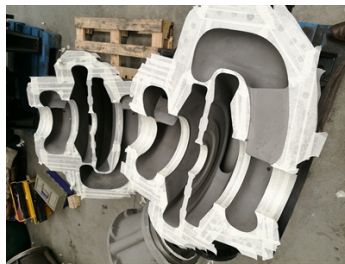
After surface preparation

Application was carried out in accordance with Belzona Know-How System Leaflets CEP-03 and the IFU of Product.

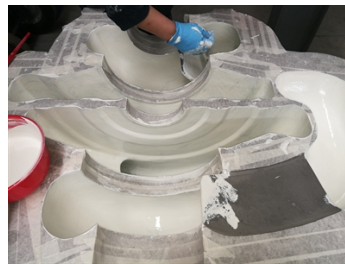
During application of Belzona 5811 DW2

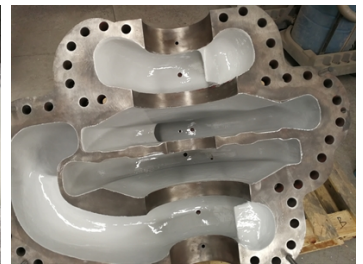
Application completed
