# Belzona Energy-saving Coatings Improve Pump Efficiency

ID: 9312

Industry: Fluid Flow  
Application: CEP-Centrifugal Pumps  
Substrate: Cast Iron  
Products: Belzona 1341 (Supermetalglide)

Customer Location: Jiangsu, China  
Application Date: May 2019

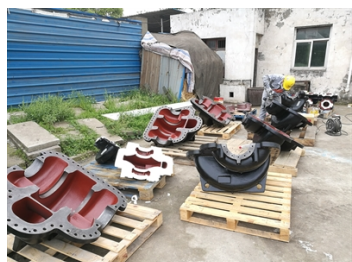
Before application

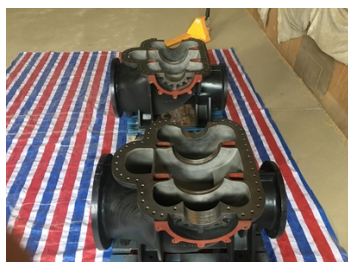
After surface preparation

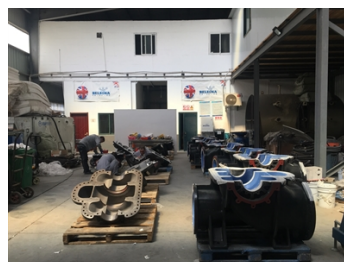
During application of Belzona 1341

Application was carried out in accordance with Belzona System leaflet CEP-10.

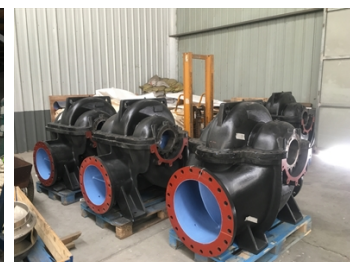
Application completed

The pump efficiency of the new pump was tested before leaving the factory and it was found that it did not reach the target value. Traditional methods of smoothing the substrate surface to reduce fluid resistance and enhance pump efficiency have had limited success. The customer chose to apply Belzona energy-saving and efficiency-enhancing coating to the overall internal flow surface of the pump casing, and the pump efficiency was improved. The effect is significant. The test of pump efficiency before and after the coating applied showed that pump efficiency increased by more than 3%, far exceeding the pump efficiency target value required for delivery and far exceeding customer expectations.
