Belzona Provides Nonskid Safety Stripping at Lube Oil Facility

ID: 9316

Industry: General Industry
Application: FPA-Floor Problem Areas
Substrate: Concrete
Products: Belzona 5231 (SG Laminate)

Customer Location: Louisiana
Application Date: March 2023

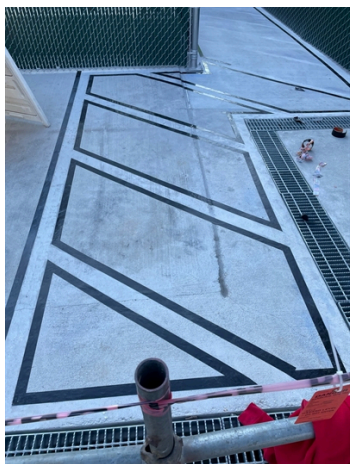
This high traffic area in this lube oil facility was in need of a nonskid safety grip system due to the potential slip and fall hazard the area presented.

Pre Job inspection

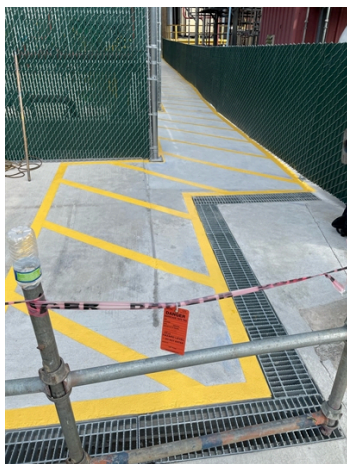
Application in progress

The concrete area was prepared using blast track machine with vac system in order to properly prepare concrete substrate for acceptance of coating and minimize dust in area. The area was then taped off to owner specified pattern prior to coating. The first coat of Belzona 5231 was applied as per manufactures recommendation and additional aggregate was applied in first coat to achieve additional nonskid properties. An additional topcoat of Belzona 5231 was then applied to encapsulate nonskid aggregate and provide long term nonskid solution.

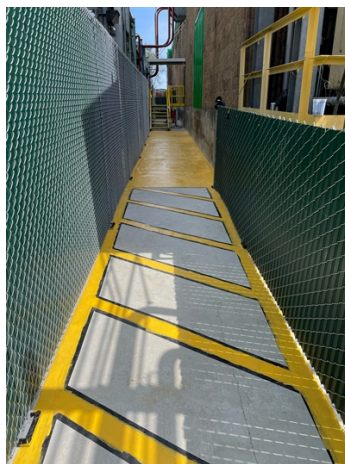
Belzona 5231 applied to half of the high traffic area

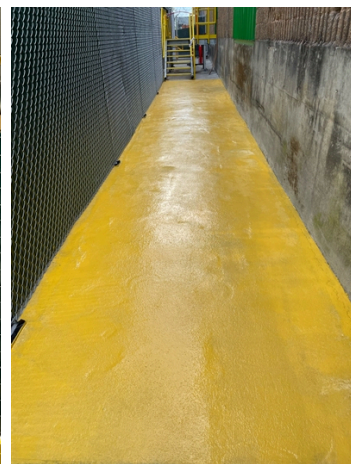
Application finalized
