Belzona Provides Nonskid Safety Stripping at Lube Oil Facility

ID: 9316

Industry: *General Industry*
Application: *FPA-Floor Problem Areas*
Substrate: *Concrete*
Products: *Belzona 5231 (SG Laminate)*

Customer Location: *Louisiana*
Application Date: *March 2023*

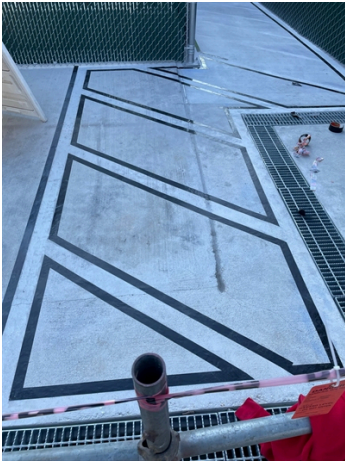
This high traffic area in this lube oil facility was in need of a nonskid safety grip system due to the potential slip and fall hazard the area presented.

Pre Job inspection

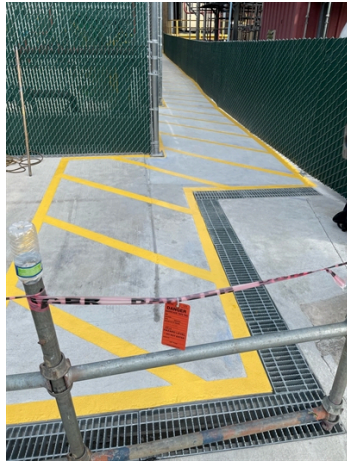
Application in progress

The concrete area was prepared using blast track machine with vac system in order to properly prepare concrete substrate for acceptance of coating and minimize dust in area. The area was then taped off to owner specified pattern prior to coating. The first coat of Belzona 5231 was applied as per manufactures recommendation and additional aggregate was applied in first coat to achieve additional nonskid properties. An additional topcoat of Belzona 5231 was then applied to encapsulate nonskid aggregate and provide long term nonskid solution.

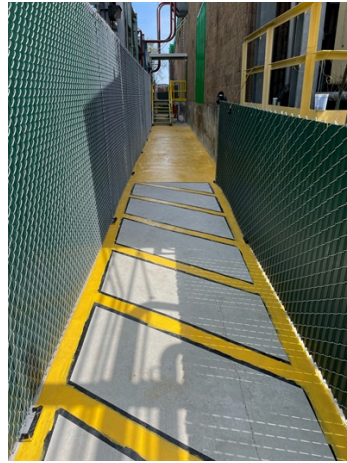
Belzona 5231 applied to half of the high traffic area

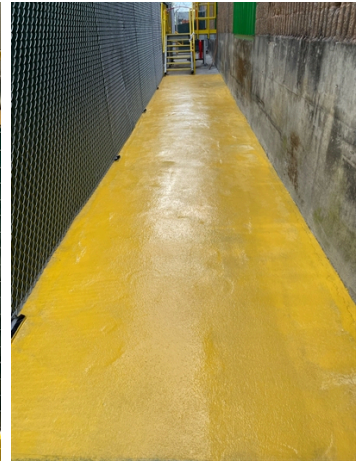
Application finalized
