# Belzona Provides Nonskid Safety Stripping at Lube Oil Facility

ID: 9316

Industry: *General Industry*  
Application: *FPA-Floor Problem Areas*  
Substrate: *Concrete*  
Products: *Belzona 5231 (SG Laminate)*

Customer Location: *Louisiana*  
Application Date: *March 2023*

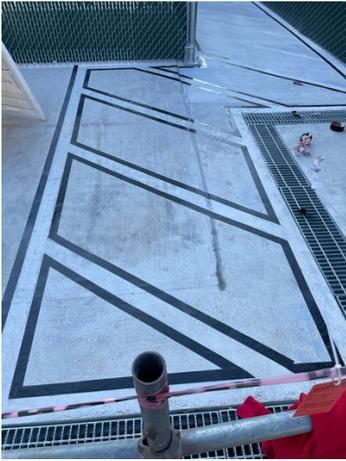
*This high traffic area in this lube oil facility was in need of a nonskid safety grip system due to the potential slip and fall hazard the area presented.*

Pre Job inspection

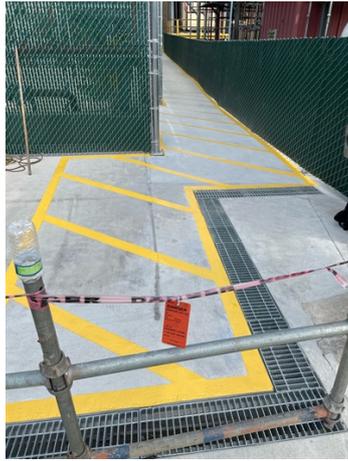
Application in progress

The concrete area was prepared using blast track machine with vac system in order to properly prepare concrete substrate for acceptance of coating and minimize dust in area. The area was then taped off to owner specified pattern prior to coating. The first coat of Belzona 5231 was applied as per manufactures recommendation and additional aggregate was applied in first coat to achieve additional nonskid properties. An additional topcoat of Belzona 5231 was then applied to encapsulate nonskid aggregate and provide long term nonskid solution.

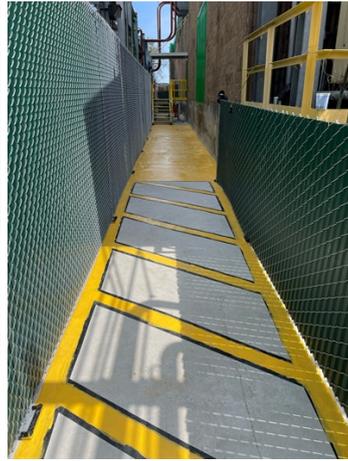
Belzona 5231 applied to half of the high traffic area

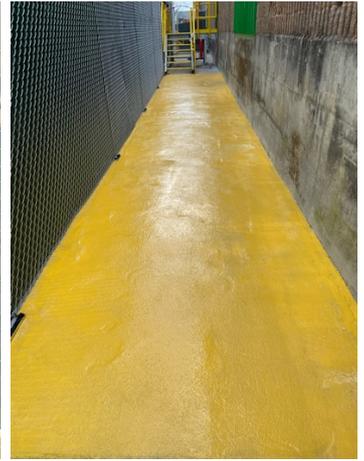
Application finalized
