Protection of new Flygt Pump

ID: 9348

Substrate: Cast Iron
Products: Belzona 1321 (Ceramic S-Metal)

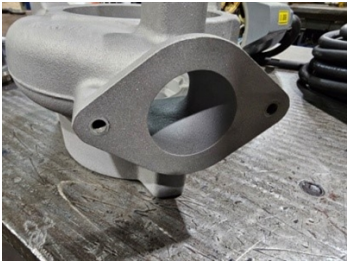
Pump after grit blasting.

Pump was grit blasted to standard SSPC SP5 and coated with Belzona 1321.

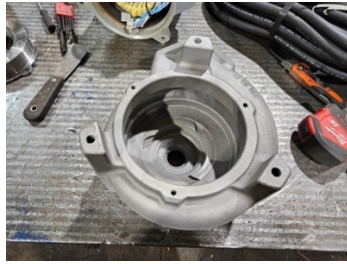
Casing after grit blasting

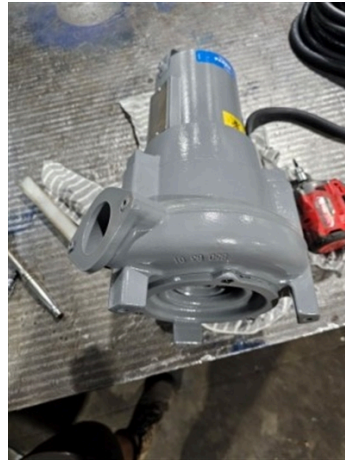
After application of Belzona.

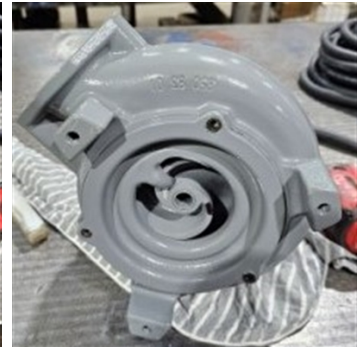
After application of Belzona.
