Belzona Repair of Floating Marine Fuel Hoses

ID: 9384

Industry: Marine
Application: SOS-Ships and Offshore Structures

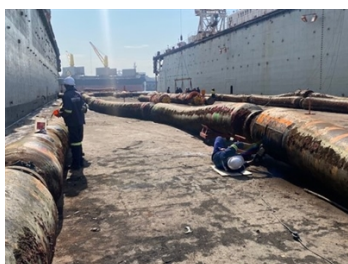
Hoses being prepared ready for repair

Upon completion of surface preparation, a Belzona Elastomer conditioner was applied to all surfaces that the Belzona 2000 Series product was to be bonded on to. Belzona 2111, Belzona 2131 and Belzona 2211 incorporating Belzona 9341 were then used to repair the hoses.

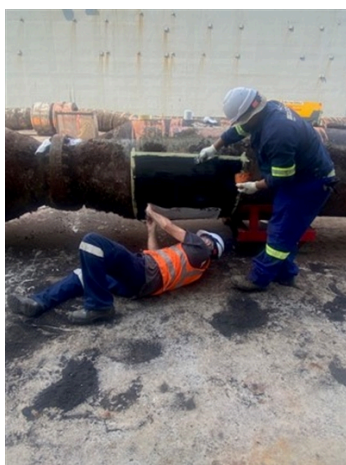
Application in progress

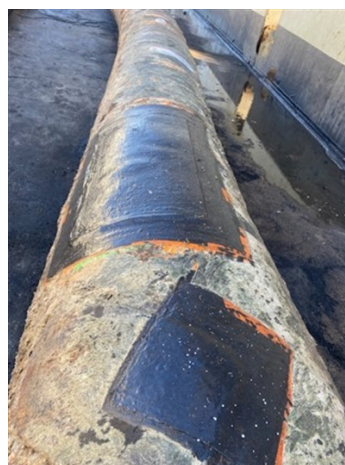
Repair area

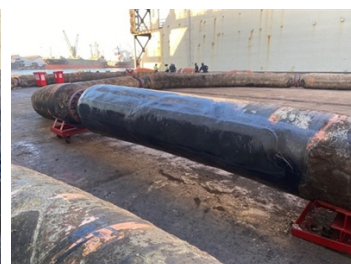
Example of a complete hose repair
